Finding Meaning and Identity in New Zealand Buildings Archaeology: The Example of ‘Parihaka’ House, Dunedin

Peter Petchey¹ & Sean Brosnahan²

ABSTRACT

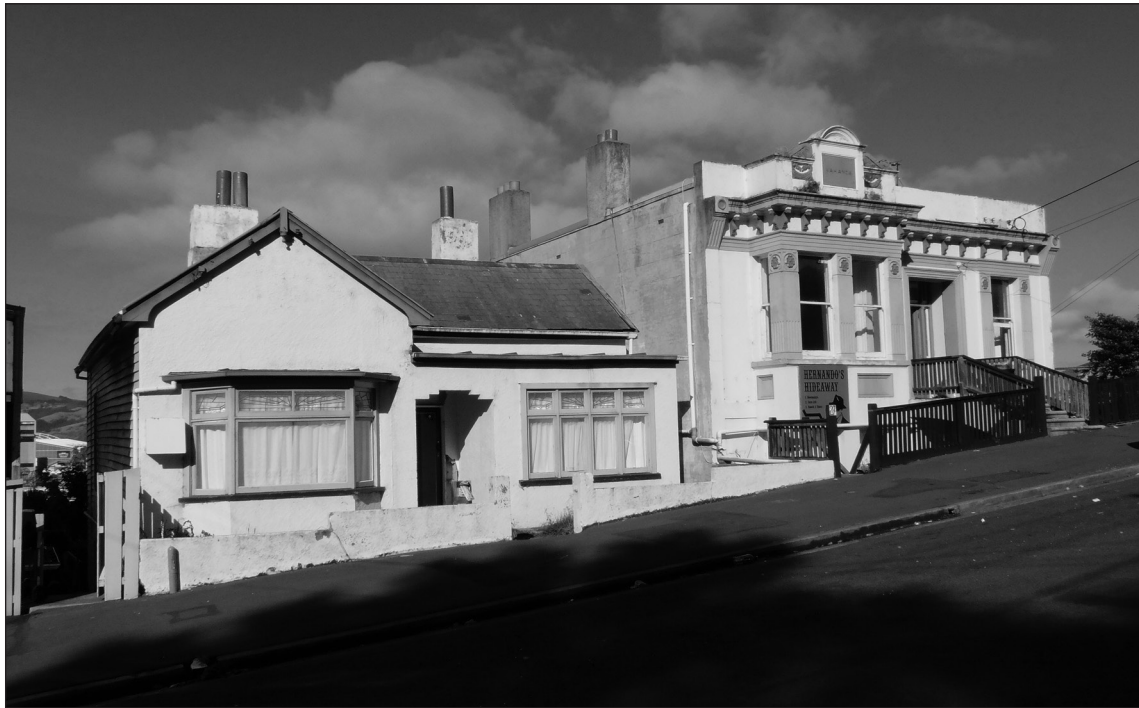
Figure 2. 'Parihaka' at 29 Queen Street on the left, and its neighbour 'Kahanga' on the right at 27 in early 2015.

Queen Street runs along the flank of Maori Hill, overlooking the North Dunedin Flat. The road is largely lined by late nineteenth and early twentieth century houses, many of which are now used as student rental accommodation. Twenty-nine Queen Street was located between two other slightly earlier houses, one of which (No. 27 on the south side) was named ‘Kahanga’ (see below for a discussion of the meaning of this name) (see Figure 2)

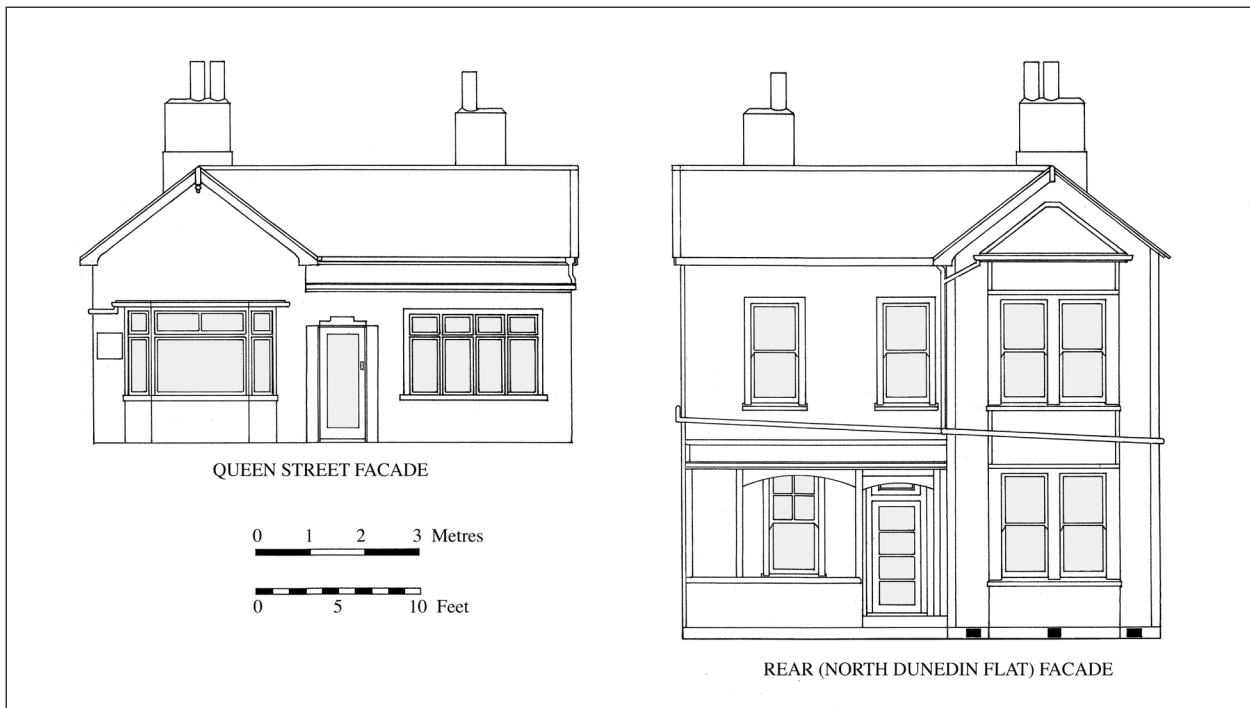
Figure 4. Front (left) and rear (right) elevations of 29 Queen Street as it appeared immediately prior to demolition in 2015.

Twenty-nine Queen Street (Figures 4 & 5) was a two storey timber building constructed on a steep slope, with the lower storey built on a cut and fill terrace below the road level, and the upper storey at road level. The house originally was a variation of a centre gutter return bay villa (see Salmond 1986: 168–169), but with the use of the bay window feature at the front of the house repeated at the rear. In effect the original structure had a T-shaped plan. The Queen Street façade was remodelled in the 1940s, and was the most modified exterior wall, while the rear façade was largely original, with the exception of the window and door arrangement on the veranda. All of the exterior architectural detail was in the front and rear walls; because of the tight location between two other (taller) houses the side walls were plain, clad with 5 ½ inch (140 mm) shiplap weatherboards with just one window in the north wall and two small windows in the south wall. The front and rear walls of the house were both very originally very visible: the front from Queen Street and the rear from the North Dunedin Flat. This visibility appears to have influenced the design of the house, with both front and rear walls being in effect public frontages, and what would normally have been the ‘invisible’ rear service elevation was instead styled to appear as a street frontage. The front (Queen Street) façade appeared from the road to be a single storey small bay villa, while the rear façade (North Dunedin Flat) appeared to be a tall two storey bay villa. This ‘double front’ design is considered in more detail later.

The eastern (rear) façade was in effect a two storey version of the original front elevation, still clad in the original 5 ½ inch (140 mm) shiplap weatherboard (Figures 4 & 8). The bay window was square sided and was capped with a hipped roof clad with 'sparrow iron' (narrow pitch corrugated iron, see Salmond 1986:103–104). Sash windows were fitted to the front and sides of the bay. The rear wall was also largely original, and the modifications that had been made were all within the rear veranda area. Upstairs two sash windows retained all of their original parts and timber architraves, although the internal spaces that they opened into had been modified (discussed below). The lower storey included the veranda, where most obvious modification was the installation of a WC on the southern end of the veranda (probably installed in 1936), but there was also clear evidence in the form of an old architrave (and framing details found inside when wall linings were stripped) that an original external door (located directly below one upstairs window) had been replaced by a window set slightly to the north. The 'new' window was a sash window, in keeping with the original windows in the house, but differing slightly in details. The main un-

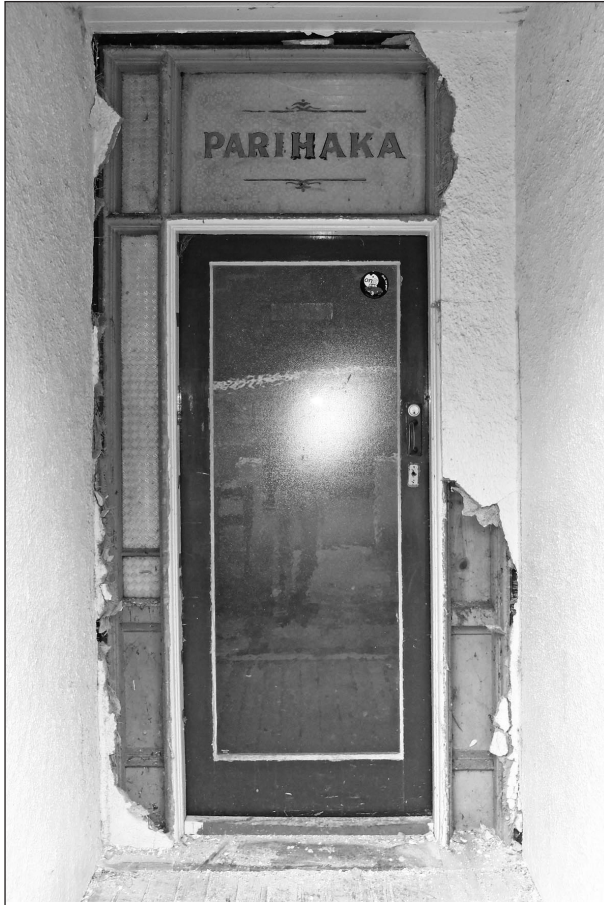
Figure 6. The front door of 29 Queen Street as the 1940s stucco was stripped back to reveal the original 1880s door frame and 'Parihaka' fanlight.

around the doorway that revealed the painted name 'Parihaka' on the fanlight (Figures 6 & 7). The timber barge boards on the gable remained, but the wooden finial had been cut off at the roof line. The chimneys had been simplified by the removal of any brick corbelling and had been plastered. The original slate roof was still in place

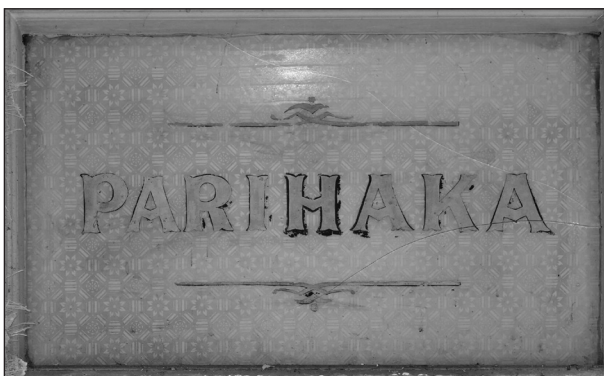
Figure 7. The 'Parihaka' fanlight. This window is now in the collection of the Otago Settlers Museum in Dunedin.

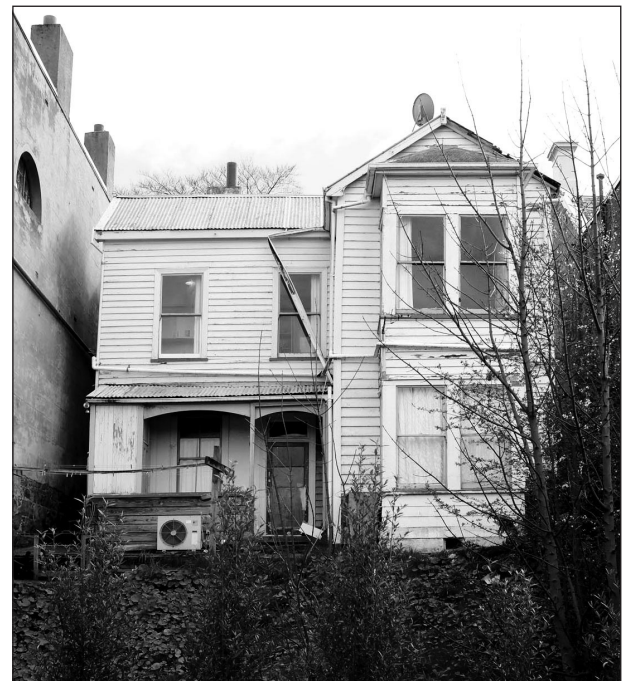
Figure 8. The rather decrepit rear elevation of 29 Queen Street in 2015, with missing bargeboard, failed guttering and decayed weatherboards. However, the formal aspect of this elevation is still apparent.

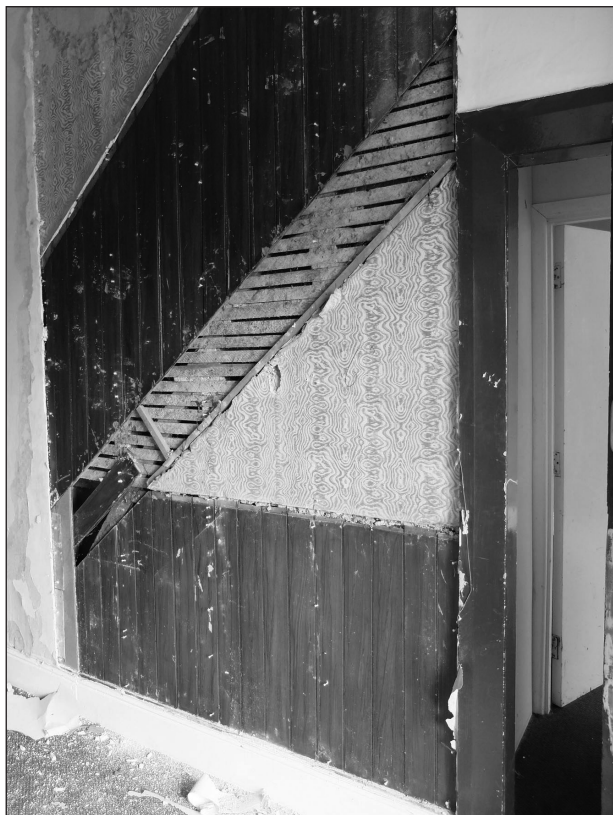
Figure 9. The downstairs hallway after a layer of plasterboard had been stripped back, revealing the outline of the original stairway and timber wainscot. Note that the visible door architrave is a twentieth century addition, probably installed at the same time as the plasterboard.

Inside the house the upper floor had five rooms that opened off a central hallway, while the lower floor had four rooms off a central hallway (Figure 5). The two floors were linked by an internal stairway that had been inserted into the north-east room space; the original stairway had been at the end of the main hallway, and the impression of its side was found in the downstairs hall when the wall linings were stripped off (Figure 9).

There had been numerous changes to the internal layout of the house, although the basic elements of the original design had survived (except for the original staircase), with a procession of rooms opening off a central hallway on both the upper and lower floors (Figure 16). The extension of one front room to occupy the space originally taken up by the front veranda was reflected in the external changes, but other internal changes only involved modifications to internal walls, the removal of the original staircase from the main hallway, and the later installation of a new staircase in a different location (Figure 9).

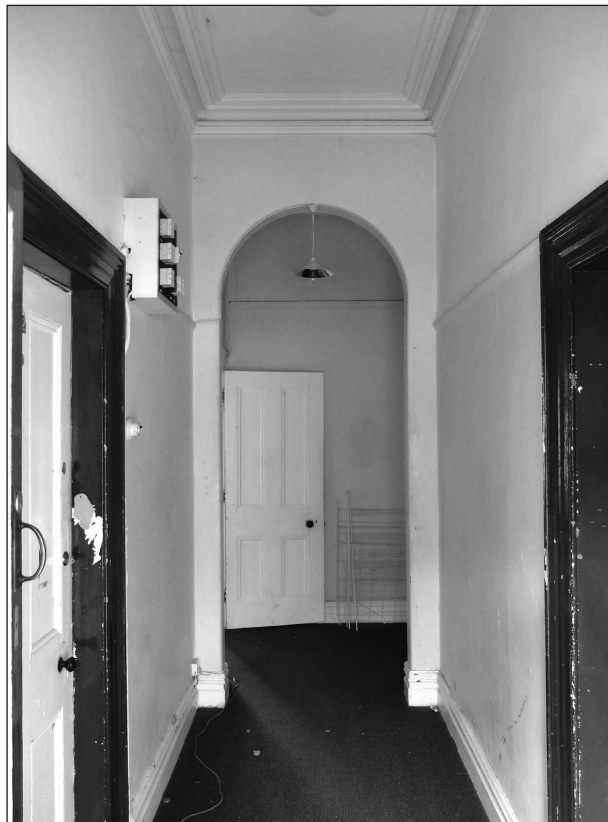
Figure 10. The main upstairs hallway, with the original lath and plaster lining in place from floor to ceiling, and the original architraves, skirting boards and ceiling cornice intact.

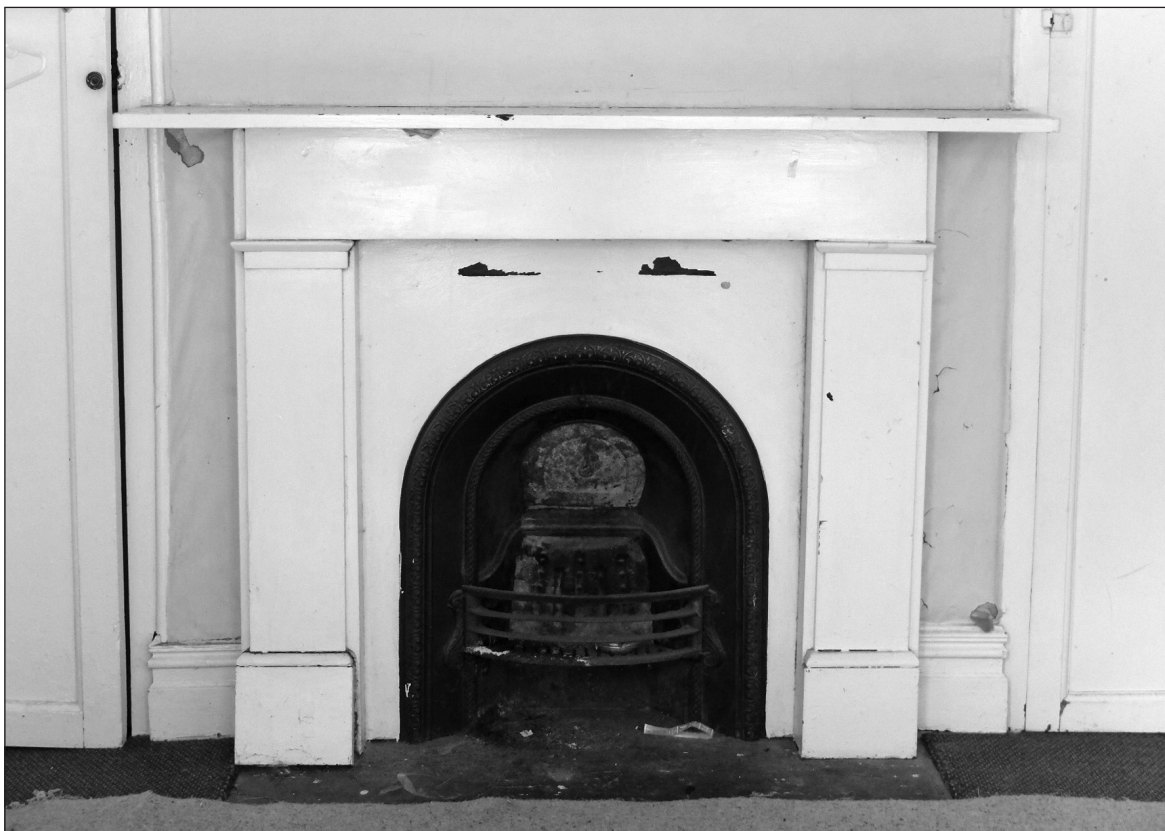
Figure 13. The original black slate fireplace in the south-west upstairs room (Room 3). This had been painted white, but retained its cast iron centre section.

in the house (Figure 13). The rear rooms retained far less original fabric, and several internal walls had been moved as the layout was changed on at least two occasions. A fragment of newspaper dated 1939 was found underneath the wall framing that had been inserted across the end of the

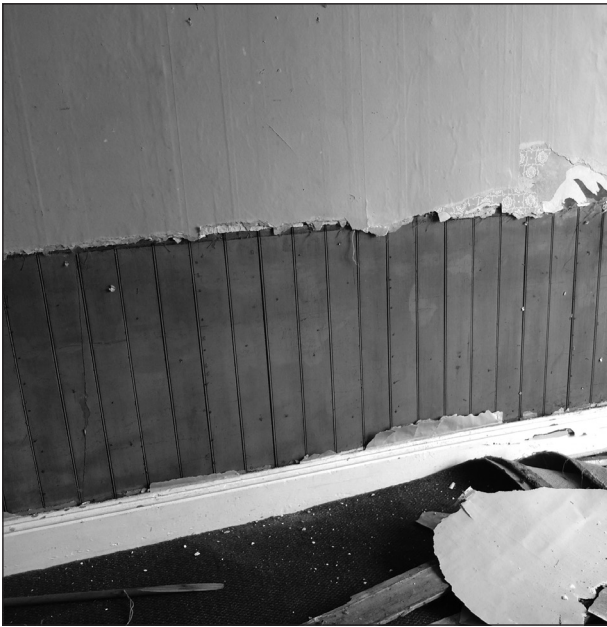
Figure 14. The timber wainscot revealed in the downstairs north-east room (Room 7) during stripping of the wall linings.

The lower floor was smaller than the upper floor, as it was built to fit into the terrace cut into the hillside, and the lower front wall was set back from the front wall of the upper floor. However, the basic layout was similar, with a central hallway with rooms opening off on either side. As already mentioned, the impression of the original staircase was found on the north wall of the hallway (Room 12) when modern wall linings were stripped. Four rooms opened off the hallway, three of which were latterly used as bedrooms (Rooms 7, 8, 9) and one as a laundry (Room 10). A notable difference in the decorative treatment of the lower storey was the use of a timber wainscot in all of the rooms. The laundry was the only room where it was still exposed, but when the wall linings were stripped in the other rooms evidence of the wainscot was found (Figure 14).

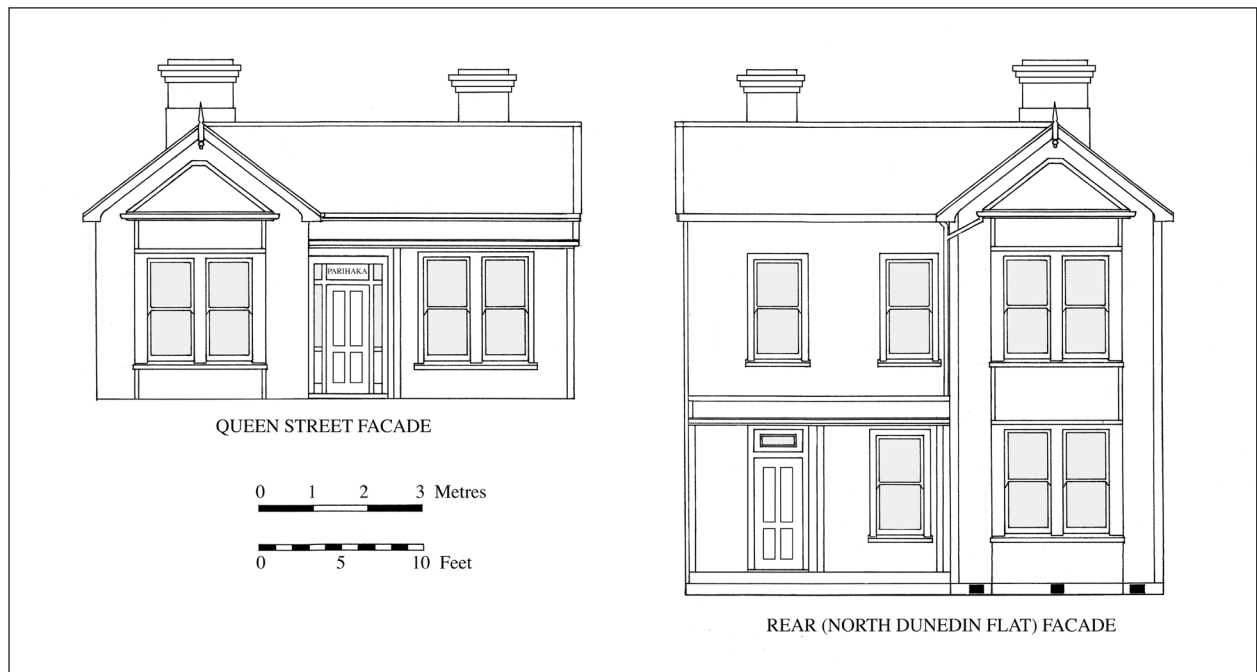
Figure 15. Reconstructions of the front and rear elevations of ‘Parihaka House’ as it probably appeared in 1880, based on examination of the house in 2015. The main uncertainties are the presence of either one or two doors that opened onto the rear veranda, and the use of a single or double sash window in the front wall.
