Bringing Christ to Whaingaroa: Te Nihinihi Wesleyan Mission Station at Raglan, New Zealand

ABSTRACT

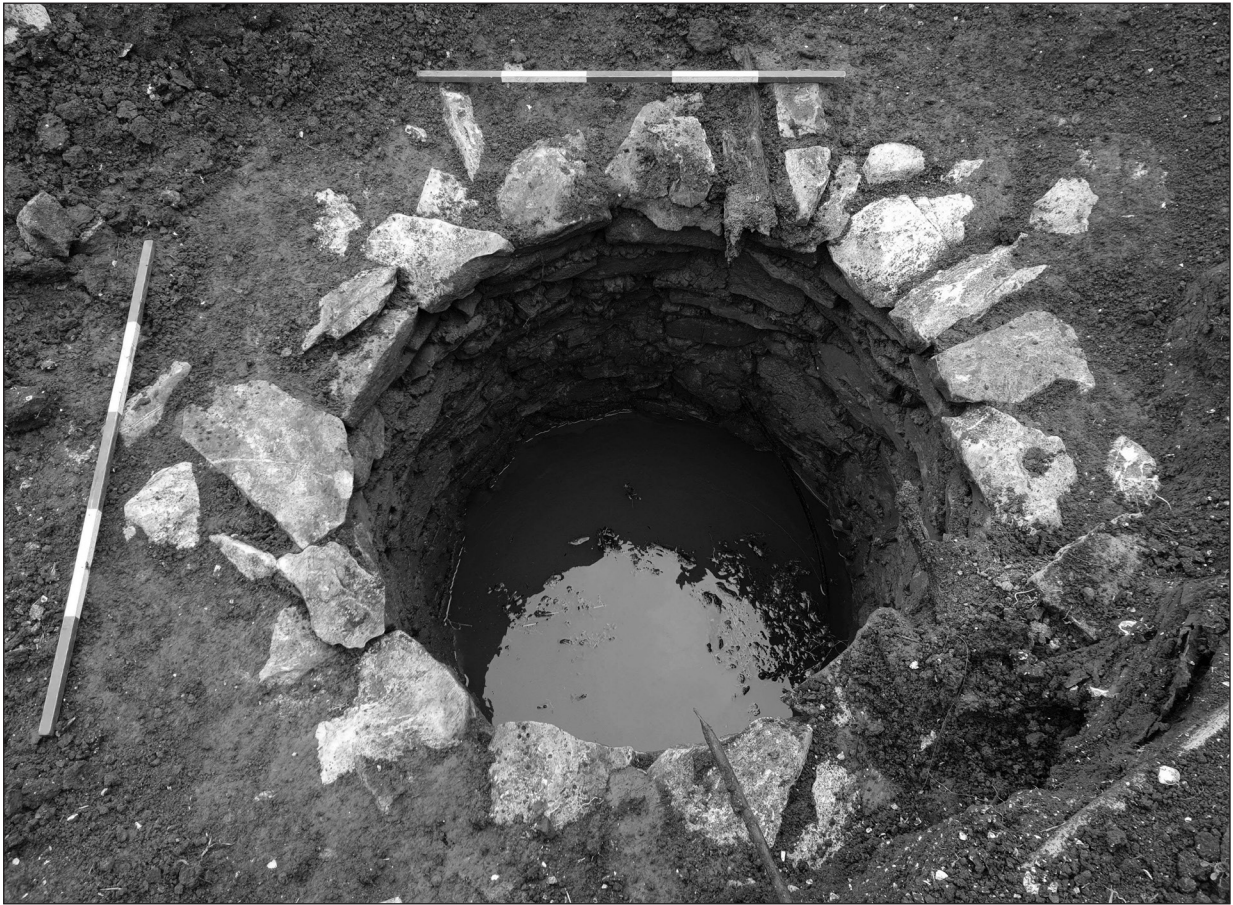
Figure 9. Mission house well.

A well, lined with limestone blocks, was found close to the eastern edge of Area 1 (Figure 9). The well was approximately 2 m diameter and 6 to 7 m deep. The limestone blocks had all been fractured from natural cleavage planes and had been quarried from outcrops on the northern side of the harbour.

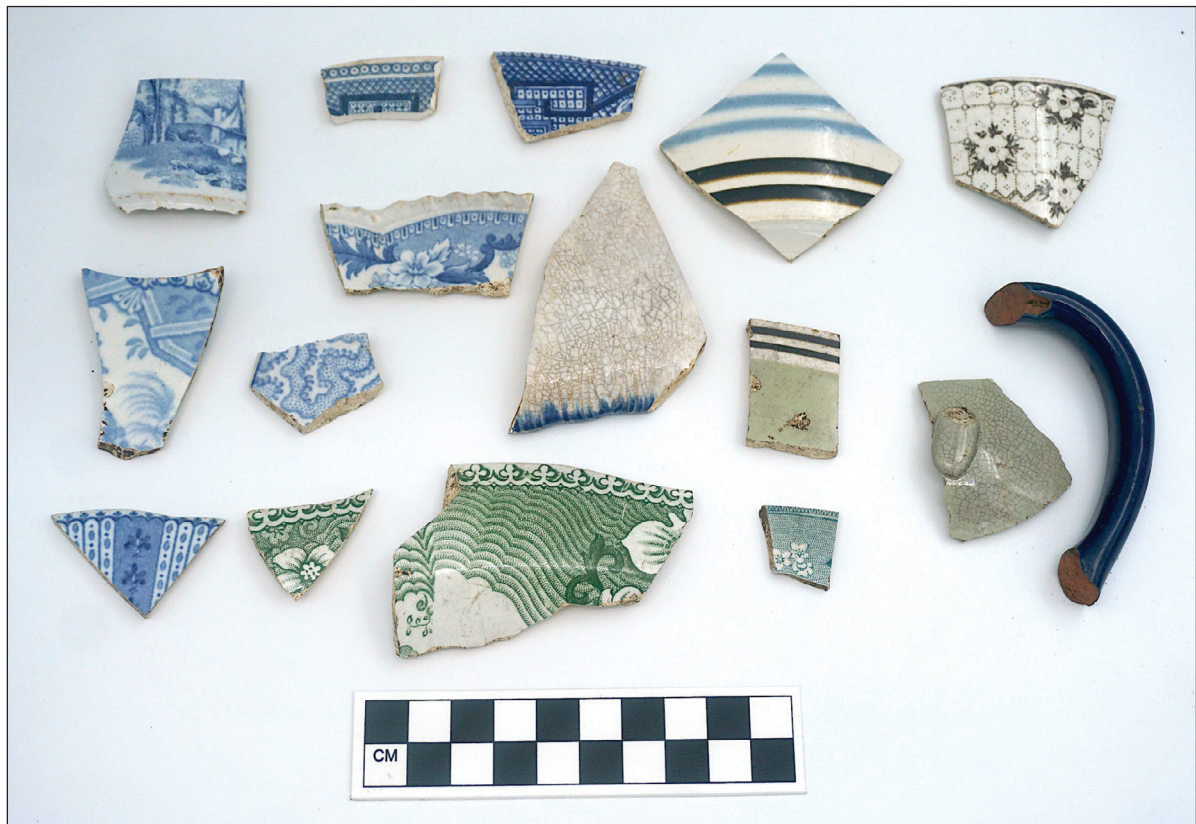
Figure 11. Selection of ceramic fragments showing commonly occurring patterns identified within Area 1.

Two hundred and six ceramic sherds were recovered, overwhelmingly from domestic ware, particularly plates and cups but also terrines, jugs, serving dishes and an egg cup. Decorative patterns were varied, with 78 patterns represented, mostly transfer printed (including Willow, Wild Rose, Fibre, Coral, and Rhine patterns) but also shell edge and industrial slip ware. Cream-ware, white-ware and stoneware were also represented (Figure 11). Four manufacturers' marks could be identified but only a large serving dish with a Copeland and Garrett Late Spode mark (Figure 12) could be dated; it was used from 1833 to 1847 (Godden 1964). This mark, along with the shell edge decoration, the general range of dates when the transfer print patterns were popular and the presence of industrial slipware indicate that this scatter of rubbish was part of the domestic crockery collection of the mission house (Furey 2010; Millar 2000). Of course, as a deposit from the early/mid-nineteenth century tobacco pipe fragments were present.

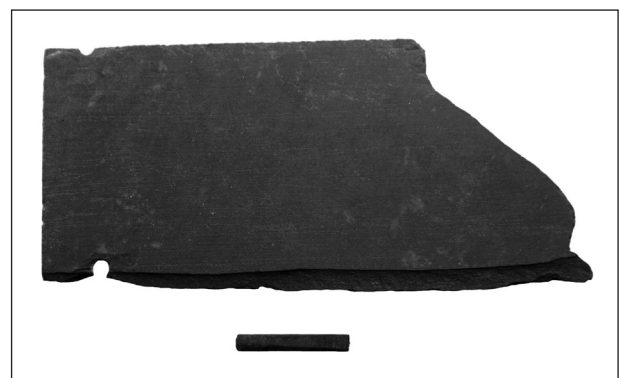
Figure 13. Writing slate and a fragment of slate pencil from within the fill of the 'doughnut' feature. Note the holes for binding.

sociation with the general shell layer (Figure 13). Twenty-four of these were broken pieces of roof slates and seven were from writing slates. Another two fragments of writing slate were found in Area 2. Several of the writing slate pieces had holes for bindings (Davies 2005). Many of the roof slate fragments had lines scribed on them suggesting that they may have been repurposed for schooling.
